ANNUAL REPORT FOR 2011

Ivy Gap Branch Site N Mitigation Site
Madison County
TIP No. R-2518A

Prepared By:
Natural Environment Unit & Roadside Environmental Unit
North Carolina Department of Transportation
December 2011

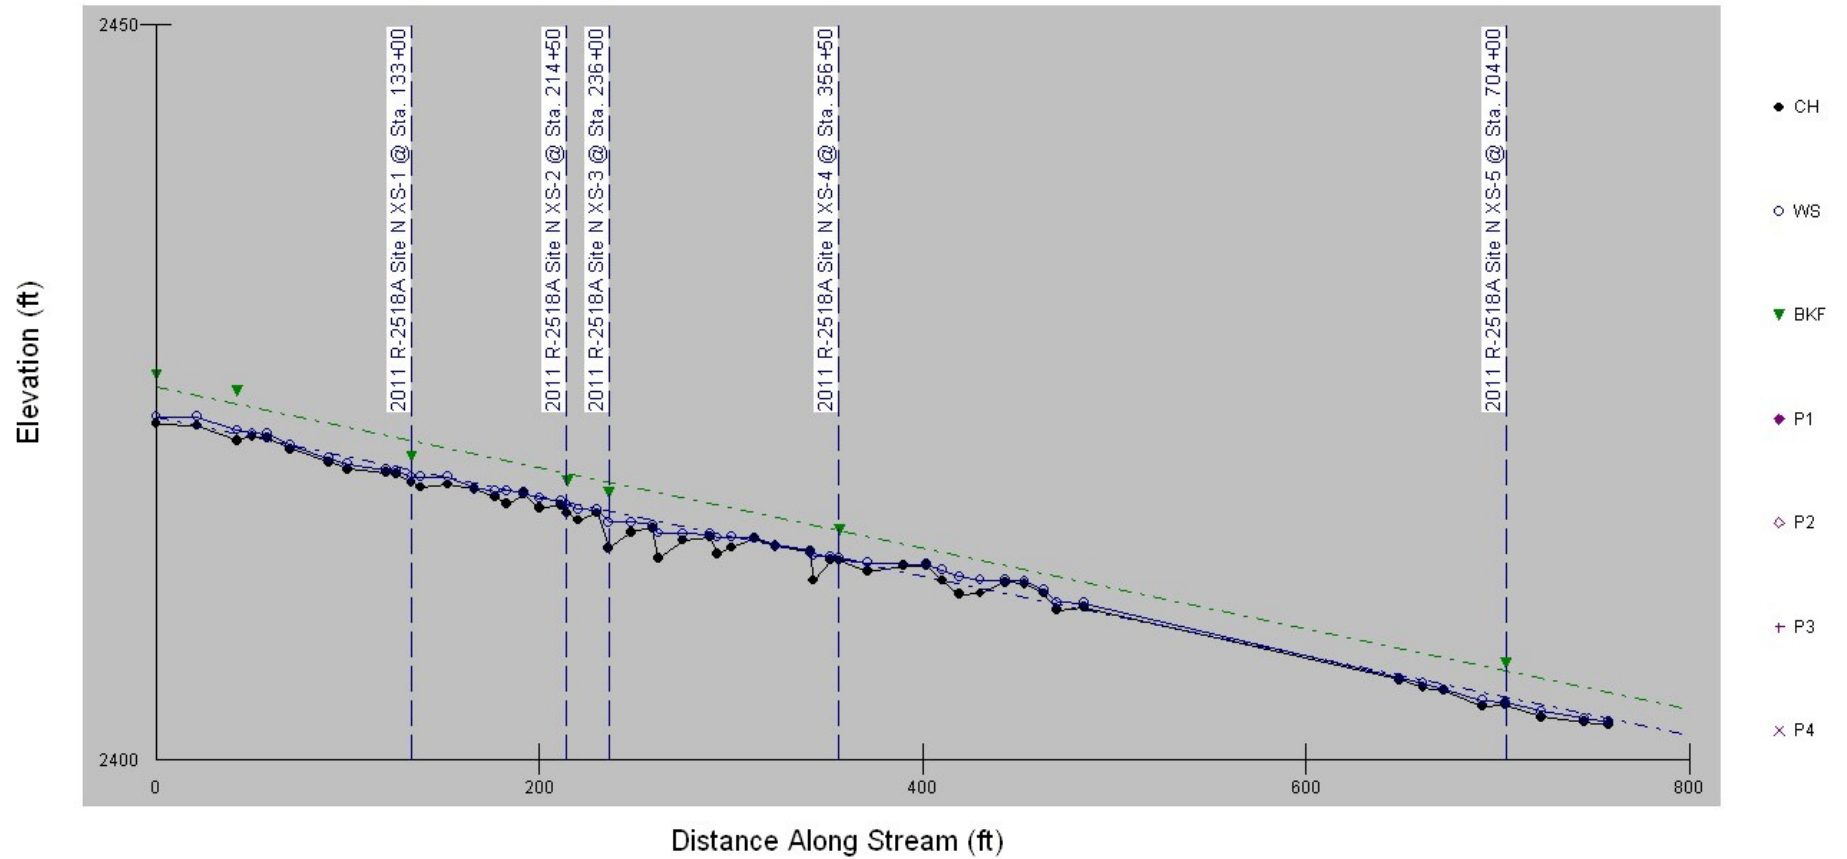
2011 R-2518A Site N Profile

Based on comparisons of the As-Built to the monitoring data, all of the cross sections appear stable with little or no active bank erosion. Graphs of the cross sections are presented in Appendix A. Future survey data will vary depending on actual location of rod placement and alignment; however, this information should remain similar in appearance. The longitudinal profile showed that the channel was stable for the 2011 monitoring evaluation. The repair work to the eroded area from Sta. 11+15 to 11+20 Rt. is scheduled for Spring 2012. Pebble counts were not required per the permit conditions and therefore were not completed.
